# TEST REPORT FIRE RESISTANCE TEST OF CONSTRUCTION ASSEMBLIES

Two Nos. of Latched, Single Acting, Single Leaf Wooden Doorset.

UL 10C: Edition 3 June 9, 2016 (R2021); Positive Pressure Fire Tests of Door Assemblies.

Test Date: 20-Dec-23 Issue Date: 29-Jan-24 Test Reference No: XK120-1A&2A

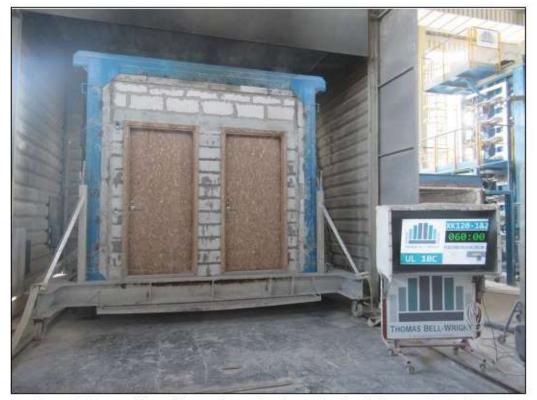
Picture 8: Unexposed face of the specimens after the termination of the test at 60:00 minutes.

Doorset A & B: The door frames and the door leaves were intact. Smoke stains were observed to have formed at the top corners of the door leaves. No through gaps were observed.

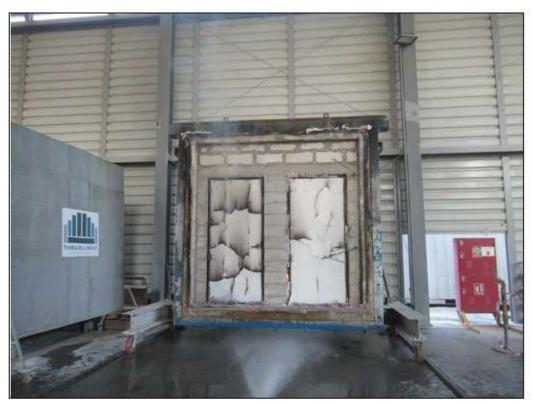
Picture 9: Exposed face of the specimens after the termination of the test.

Doorset A: The door frame was observed to have completely charred. The facings and the subfacings of the door leaf was observed to have deteriorated exposing the core of the door leaf. The door closer was observed to have deteriorated. The door handle was observed to have deflected.

Doorset B: The door frame was observed to have completely charred. The facings and the subfacings of the door leaf was observed to have deteriorated exposing the rails and the stiles and the core of the door leaves. The door closer was observed to have deteriorated. The door handle was observed to have deflected.

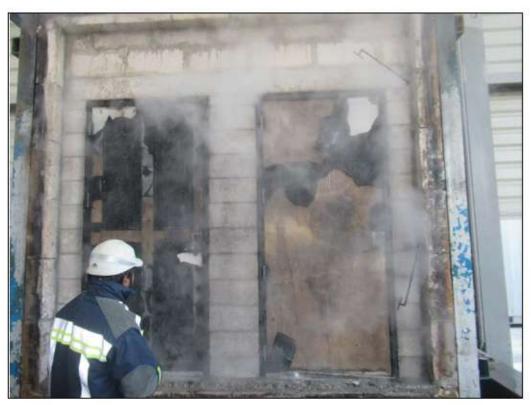
Picture 11: Exposed face of the specimens after the termination of the hose stream test.

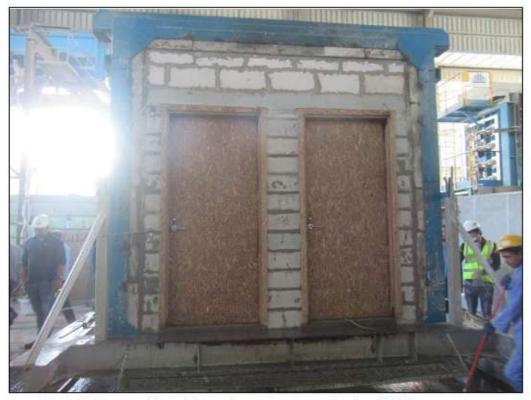
Picture 12: Unexposed face of the specimens after the termination of the hose stream test.
